## Mechanism of Charge Induced Plasma Damage to EPROM Cells During Fabrication of Integrated Circuits

C.K. Barlingay and Randy Yach  
Microchip Technology Inc., 1200 S 52nd Street, Tempe, AZ 85281

**Abstract** Plasma damage mechanisms can be very complex, especially when manufacturing non-volatile memories such as EPROM and flash memories. Plasma damage at via etch can manifest itself as a charge retention failure in the memory cell during product testing. This paper investigates the interaction of UV radiation, classical plasma charging due to non-uniform plasma, and standard integrated circuit fabrication procedures in order to propose an apparent charge loss failure mechanism for non-volatile memories.

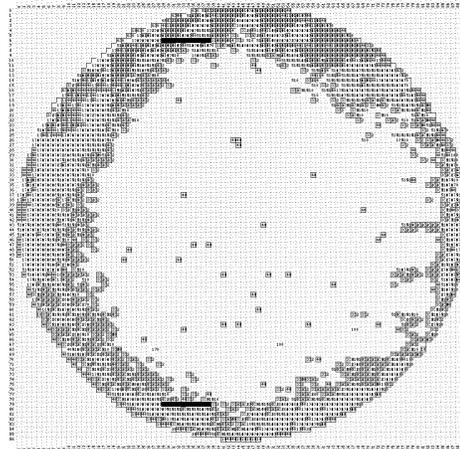
In a previous paper [7], it was reported that plasma damage was observed at the edges of wafers resulting in charge retention failures of the EPROM memory array during product testing (Figure 1). The activation energy for this charge loss was approximately 0.6 eV. This damage could not be eliminated by using different chamber type, or by varying process pressure, process

Figure 1  
Circuit failure pattern (dark areas)

The failure pattern on the wafer, shown in figure 1, correlated directly to the CHARM-2 positive potentials shown in Figure 2. The UV distribution was nearly uniform across the entire wafer.

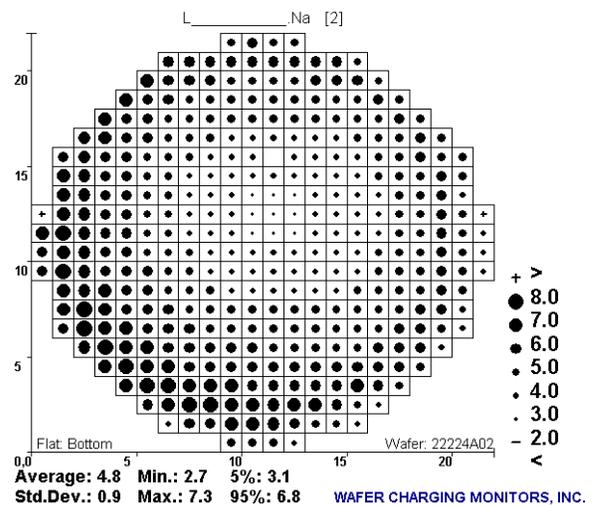
Figure 2  
CHARM-2 positive potentials

During the via etch, a non-uniform plasma develops a positive potential over the wafer as seen in Figure 2. The presence of CO in different concentrations generates UV light that makes the oxide in the memory array more, or less, conductive. When the metal in the vias is exposed to the non-uniform plasma in the presence of UV light, the memory cells become programmed to different levels according to the radial pattern shown in Figures 1 and 2. This negative charge remains stored on the floating gate during the forming gas anneal step. The hydrogen in the forming gas anneal creates localized high concentrations

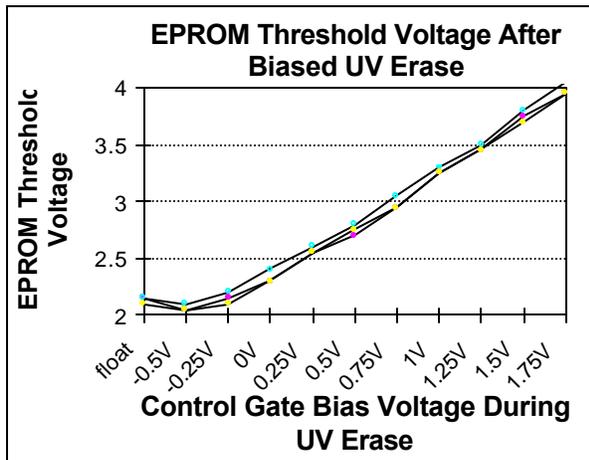
Figure 3

Earlier work was carried out at Microchip Technology Inc. to investigate how UV erase of EPROM cells works under gate bias conditions [9]. It was shown that with a bias applied to the control gate of an EPROM memory cell during UV erase, the charge stored on the floating gate of the cell could be predicted. This phenomena had the effect of programming the EPROM cell to a threshold voltage that was directly

proportional to the bias voltage applied to the control gate during UV erase (Figure 3).

EPROM threshold voltage after biased UV erase

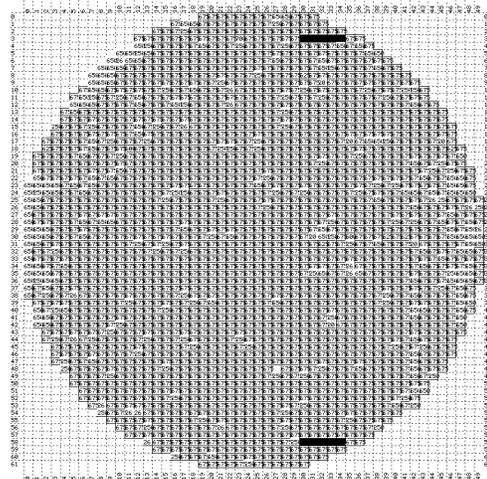
Figure 4

To confirm this, an experiment was performed using four wafers programmed by an electrical tester. Two of the wafers were then UV erased using a commercial UV lamp. All four wafers were run through the forming gas anneal process. The two wafers that were *not* UV erased prior to anneal exhibited charge retention failure across the entire wafer (Figure 4). The other two wafers exhibited normal test yield with no fallout for charge retention loss.

Map of failures from programmed wafer after forming gas anneal. Failures appear dark.
