Comparison of CHARM-2 and Surface Potential Measurement to Monitor Plasma Induced Gate Oxide Damage

Ming-Yi Lee, John R. Hu, Wilbur Catabay, Philippe Schoenborn and Aldona Butkus
LSI Logic Corporation, 3115 Alfred Street, Santa Clara, CA 95045 USA

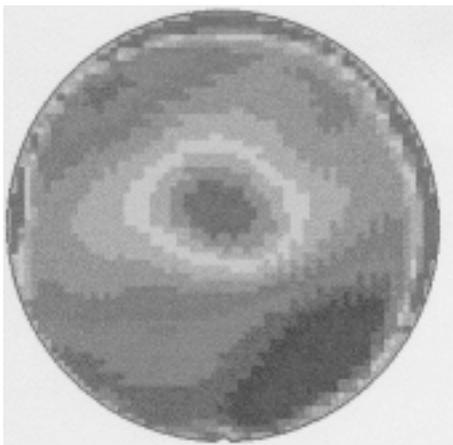
photoresist strip process has highest positive voltage, as shown in Figure 1, compared with other plasma processes. The wafer map shows a center circle (bull's-eye) pattern which is similar to the device burn-in failure wafer map. The oxide deposition process showed a negative potential with a gradient voltage drop across the wafer, as shown in Figure 2. The SPM results indicated the source of damage is likely to be the photoresist plasma ashing process.

Figure 1. SPM positive potentials; resist asher. Center high (bull's-eye pattern).

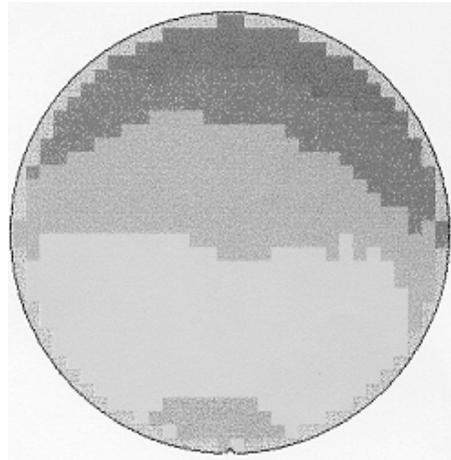
Figure 2. SPM negative potentials; oxide deposition. Directional voltage drops from top to bottom.

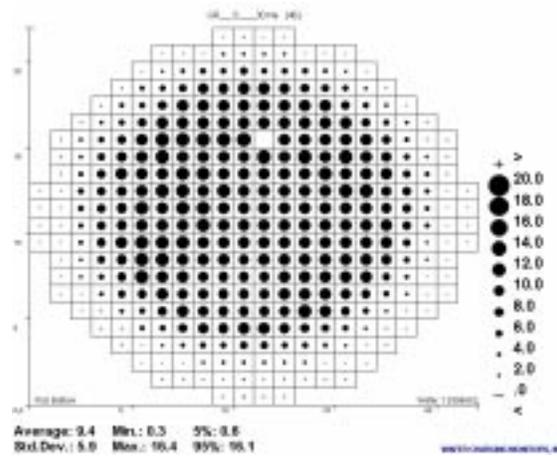
Figure 3. CHARM-2 positive potentials; resist asher. The potential sensors are saturated at 16 V.

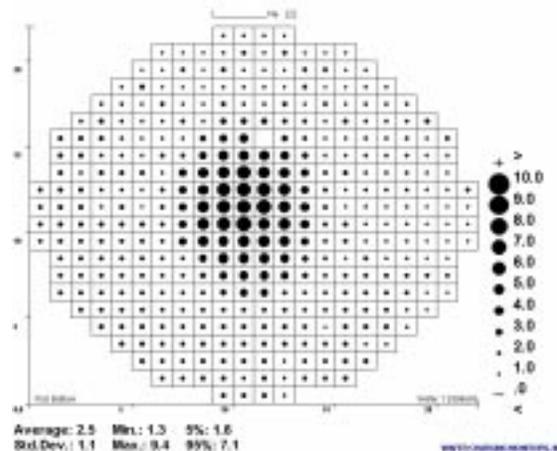
Figure 4. CHARM-2 positive potentials, oxide deposition.

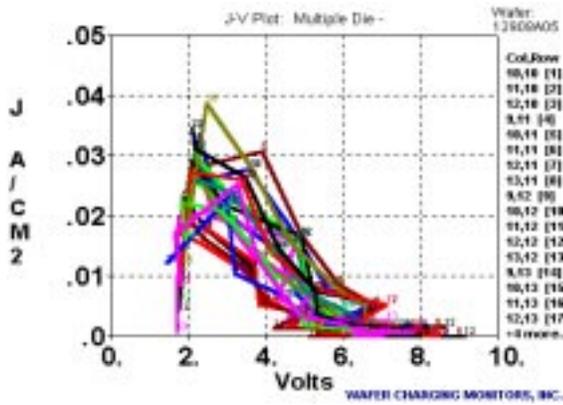
Figure 5. CHARM-2 positive J-V plots from die in the center of the wafer, oxide deposition process.

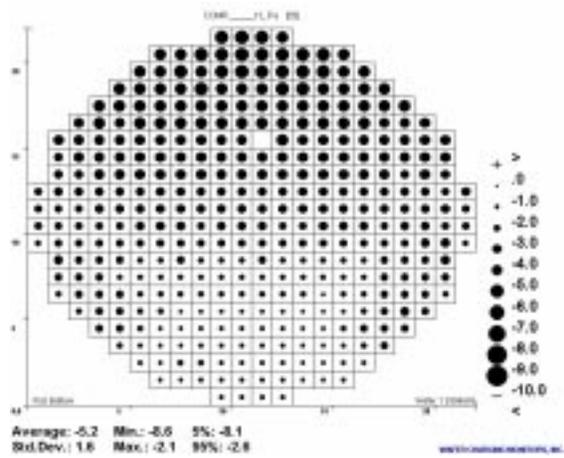
Figure 8. CHARM-2 negative potentials; oxide deposition.

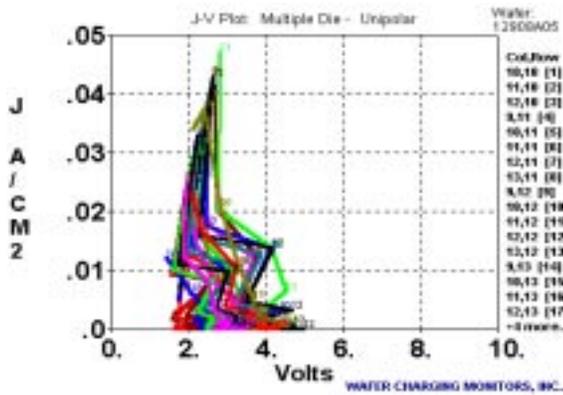
Further analysis of CHARM-2 data of oxide deposition process showed that positive J-V plots from unipolar charge flux sensors in center dies showed shift to lower potentials, as shown in Figure 6, indicating that positive charging occurred at elevated temperatures. (CHARM-2 unipolar charge flux sensors use diode in parallel with current-sensing resistor, as shown in Figure 7. At elevated temperature, leakage current through the diode reduces current through the current-sensing resistor. This lowers the voltage across the resistor, causing lower voltage and current readings. This shifts the J-V plots toward the origin.)

Figure 6. CHARM-2 positive J-V plots from die in the center of the wafer; unipolar charge-flux sensors; J-V plots shift to lower potentials, indicating that positive charging occurred at elevated temperature.

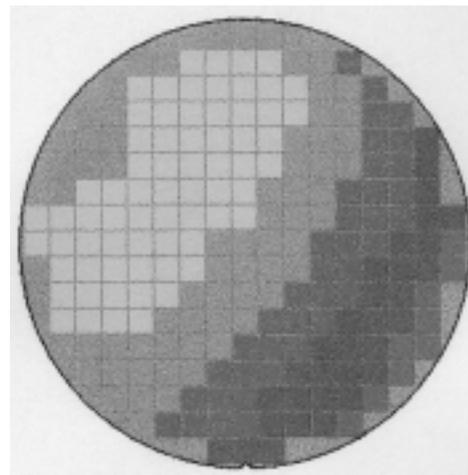
From CHARM-2 data, it is clear that damage happened at the deposition process step. The SPM method reveals the last event of the wafer process history. It may not correlate to the source of damage. To investigate the source of negative potential, the wafer was intentionally rotated before being loaded into the chamber. Figure 9 shows the SPM response also correlated to the rotation. It was concluded that negative potential is coming from the wafer moving out of chamber while plasma is still on. This was confirmed by turning the plasma OFF before moving the wafer, which resulted in SPM bulls-eye pattern.

Figure 9. SPM negative potentials; oxide deposition with wafer rotated.

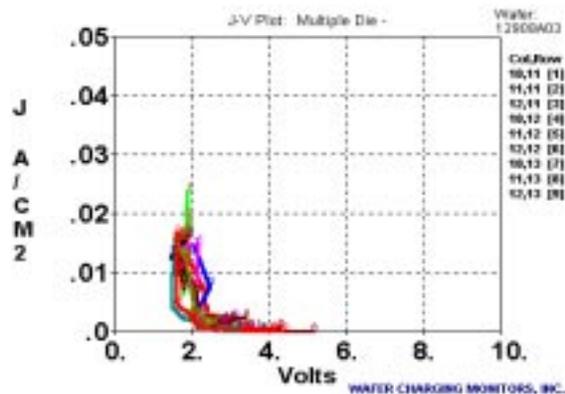
Figure 10. CHARM-2 positive J-V plots from die in the center of the wafer.

Process optimization was done on oxide deposition process to prevent the gate oxide damage. CHARM-2 wafer was used to monitor the plasma process of the new optimal process. It has reduced the positive plasma J-V current significantly, as shown in Figure 10. CHARM-2 data in Figure 10 predicted that damage should not occur with new optimal process. The device wafer results proved the new process condition is free of plasma induced gate oxide damage. No more gate leakage current was observed.
