Utility of CHARM^â-2 in Diagnosing Sources of Plasma Charging Damage in High Density Etchers and in Assisting Hardware Development

Stanley Siu, Roger Patrick, and Vahid Vahedi

Lam Research Corporation, 4400 Cushing Parkway, Fremont CA 94538-6401, USA

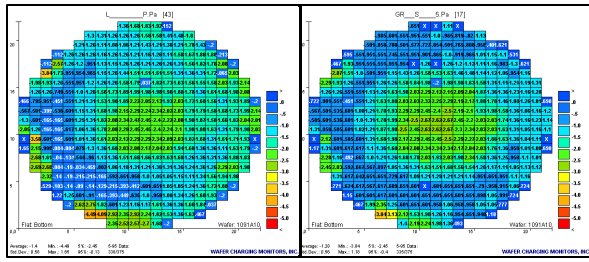
Although electron shading is the dominant plasma damage mechanism, a situation was encountered where a newly developed poly process showed yield loss at the wafer center. The cause of yield loss was low V_{BD} for the poly antenna WAT testers. The antenna ratio was not excessive, and the plasma density was quite low for the process, indicating that electron shading type damage was not the root cause. A CHARM-2 wafer was used to test the process to see if there were any problems unique to this process. A CHARM-2 signature mirroring the yield map was seen (figure 1). Areas of high charging on CHARM-2 were areas where there was no yield.

Figure 1. Potential sensors showing charging when running customer process. Unipolar (left) and guard ring sensors (right).

It was then determined that the top to bottom power ratio was too low – this resulted in the plasma being driven by the bottom RF which led to a very non-uniform center to edge plasma. Splits run on CHARM-2 showed that increasing top power by 2X reduced the charging signature (figure 2), and reducing the bias by $\frac{1}{2}$ eliminated all charging (figure 3). A comparison of the current sensors showed available current of about 25 micro-amps/cm² for the damaging process and noise level current readings for the new TCP controlled process (figure 4). When this retuned process was tested on the customer product lot, the profiles met specifications, and the yield problem was eliminated.

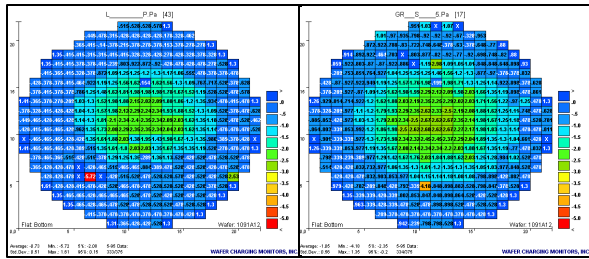
Figure 2. Increasing TCP power by 2X reduced but did not eliminate charging.

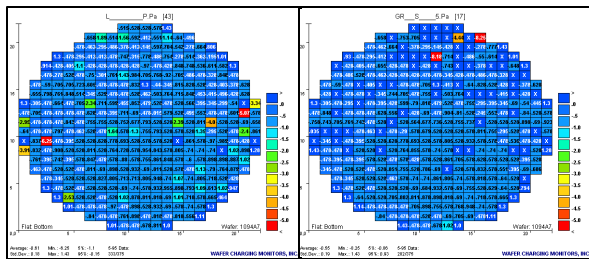
Figure 3. Increasing TCP power 2X and decreasing bias by half eliminated charging.

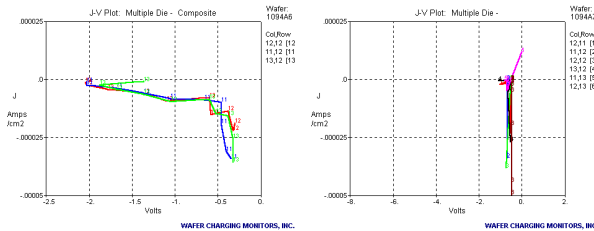
Figure 4. Current sensors comparing baseline (left) with charging free process (right).

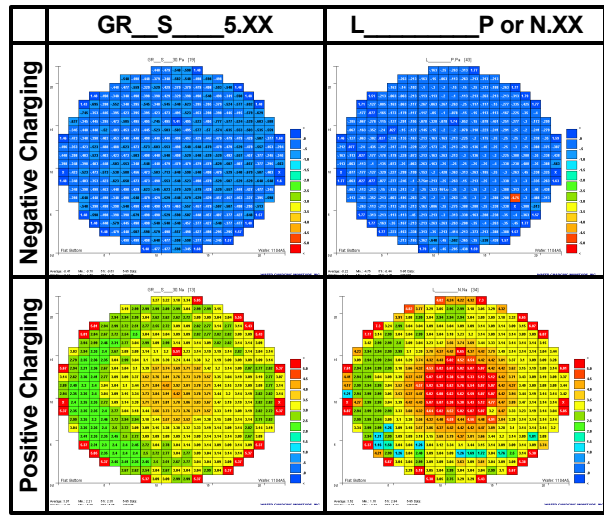
For one customer there was a yield loss problem in the center of the wafer (again, low Q_{BD} problem). A CHARM-2 test was run with the same process on a lab tool and showed no charging. It was then found that the customer tool had its lifter pins improperly adjusted so that the pins were actually touching the backside of the wafer. The lab tool then had its pins adjusted to touch

the backside of the wafer and a CHARM-2 test was run. A charging pattern was seen that mirrored the customer's yield loss pattern (figure 5).

Once the customer had the lifter pins properly adjusted, the yield levels returned to normal. It is not certain what the charging mechanism was, but it was speculated that either uneven RF coupling through the wafer (differences in the wafer-to-ESC gap) caused the charging, or the pins provided an RF path through the wafers to ground.

Figure 5. CHARM response with lifter pins touching bottom of wafer.

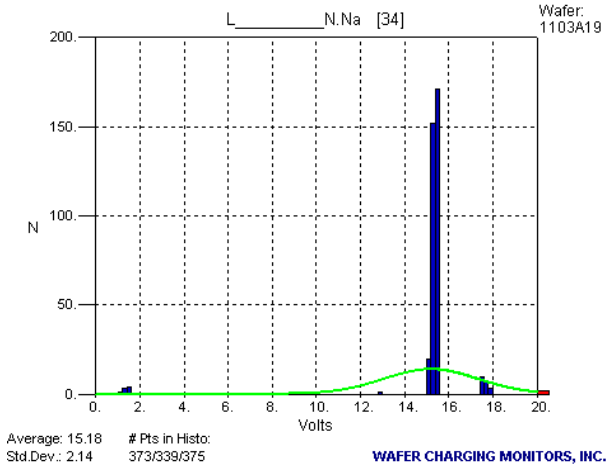
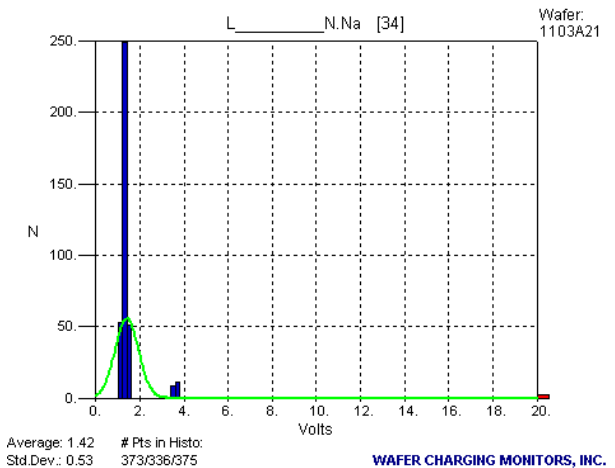
CHARM-2 was used to diagnose a charging problem stemming from electrostatic clamping. For monopolar electrostatic chucks (ESC) it was discovered that the sequencing of the plasma ignite and ESC on steps were crucial to avoiding charging damage (5). It was found that if the ESC was turned on before the plasma was ignited, a large positive CHARM-2 signature was seen (figure 6a), whereas no negative charging was seen. Further testing showed that this charging was due to the wafer potential rising to the chuck potential and causing a DC glow discharge. The DC glow discharge was also confirmed in two ways: 1. application of the bottom RF, while not enough to ignite a plasma, when the DC discharge occurred was able to sustain a visible discharge, as its application would sustain a visible discharge, and 2. onset of discharge caused the wafer to clamp, indicating a plasma was ignited. Since the wafer is at a large negative potential, the unipolar signature from CHARM-2 that is opposite in polarity to the chucking voltage also confirms this mechanism.

In the case where the plasma is ignited first, the wafer potential is held near the plasma potential, and the subsequent ESC chucking voltage will not induce charging damage. Subsequent CHARM-2 tests with this sequence showed no charging (figure 6b), and subsequent steps have been taken to ensure that etchers with monopolar chucks have the proper turn on sequence.

Figure 6. Saturated CHARM sensors from improper chucking sequence (top) and with proper sequence (bottom).

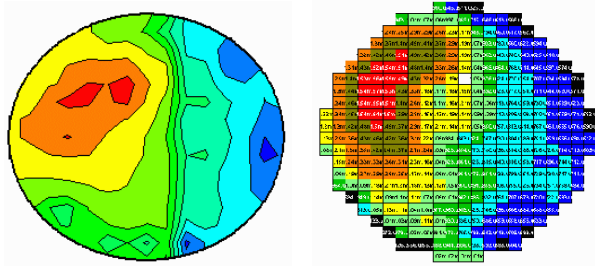
In some early CVD development work at Lam a high temperature ESC was being prototyped. As part of the standard procedure in the development work, the ESC was tested with a CHARM-2 wafer. An unexpected large CHARM-2 signature was seen. Later work showed that there was a large variation in the ESC dielectric, and this variation correlated to the charging map generated by CHARM-2 (figure 7). The non-uniform dielectric generated a non-uniform RF drop across the ESC dielectric, which resulted in non-uniform RF coupling through the wafer. Needless to say, this ESC was promptly decommissioned.

Figure 7. ESC dielectric thickness map (left) and corresponding CHARM map (right).

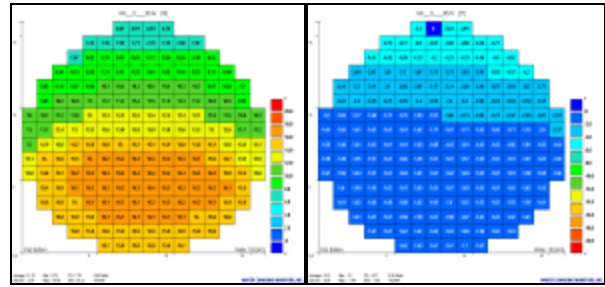
This type of non-uniform RF coupling through the wafer was seen in another situation where there was a large Si particle (100-200 μm diameter) on the ESC (figure 8a). Of course, the wafer did not chuck properly, but the non-uniform gap between the wafer and the ESC top surface generated a non-uniform RF drop across the wafer resulting in a large positive and negative gradient across the wafer. The particle caused one side of the wafer to lift and a corresponding top-bottom charging map was seen. Once the ESC was cleaned, the charging was eliminated.

Figure 8b. CHARM signature due to particle (8a) under the wafer.

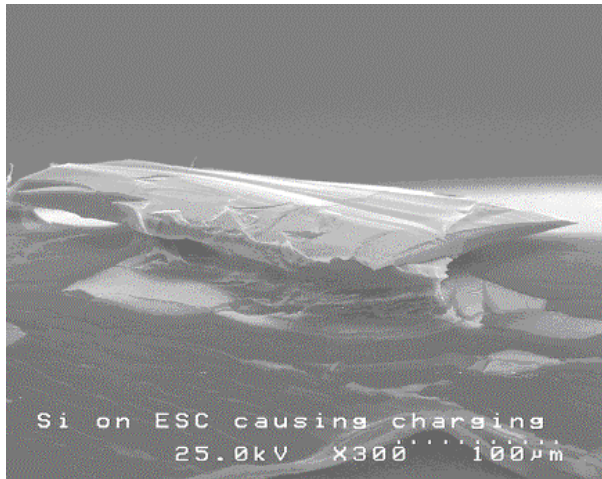
Figure 8a. SEM image of particle causing CHARM signature.

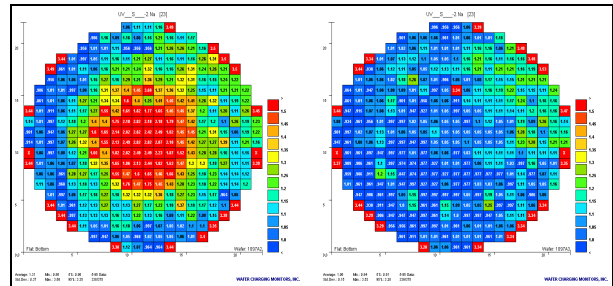
This last case shows the utility of CHARM UV sensors in assisting hardware design. In prototyping work baffle design for a down stream etcher, it was important to block the ions and UV from the wafer. Although line of sight can be easily determined, unforeseen reflections that could allow UV to the wafer surface is more difficult to determine. CHARM-2 was used to ensure that baffle design did indeed block all ions and UV at the wafer level. Although the non-optimized baffle did not permit ions to reach the wafer (CHARM-2 map was clean), the baffle did allow UV through (Figure 9). With the final optimized baffle design, all the reflections were eliminated, and there was no UV response from CHARM-2.

Figure 9. UV sensors, non-optimized baffle (left) versus optimized baffle (right)
